Research Report  
KTC-94-21

EVALUATION OF EDGE DRAINS  
HEADWALLS AND OUTLETS  
ON WESTERN KENTUCKY PARKWAY AND  
PENNYRILE PARKWAY

September 1994

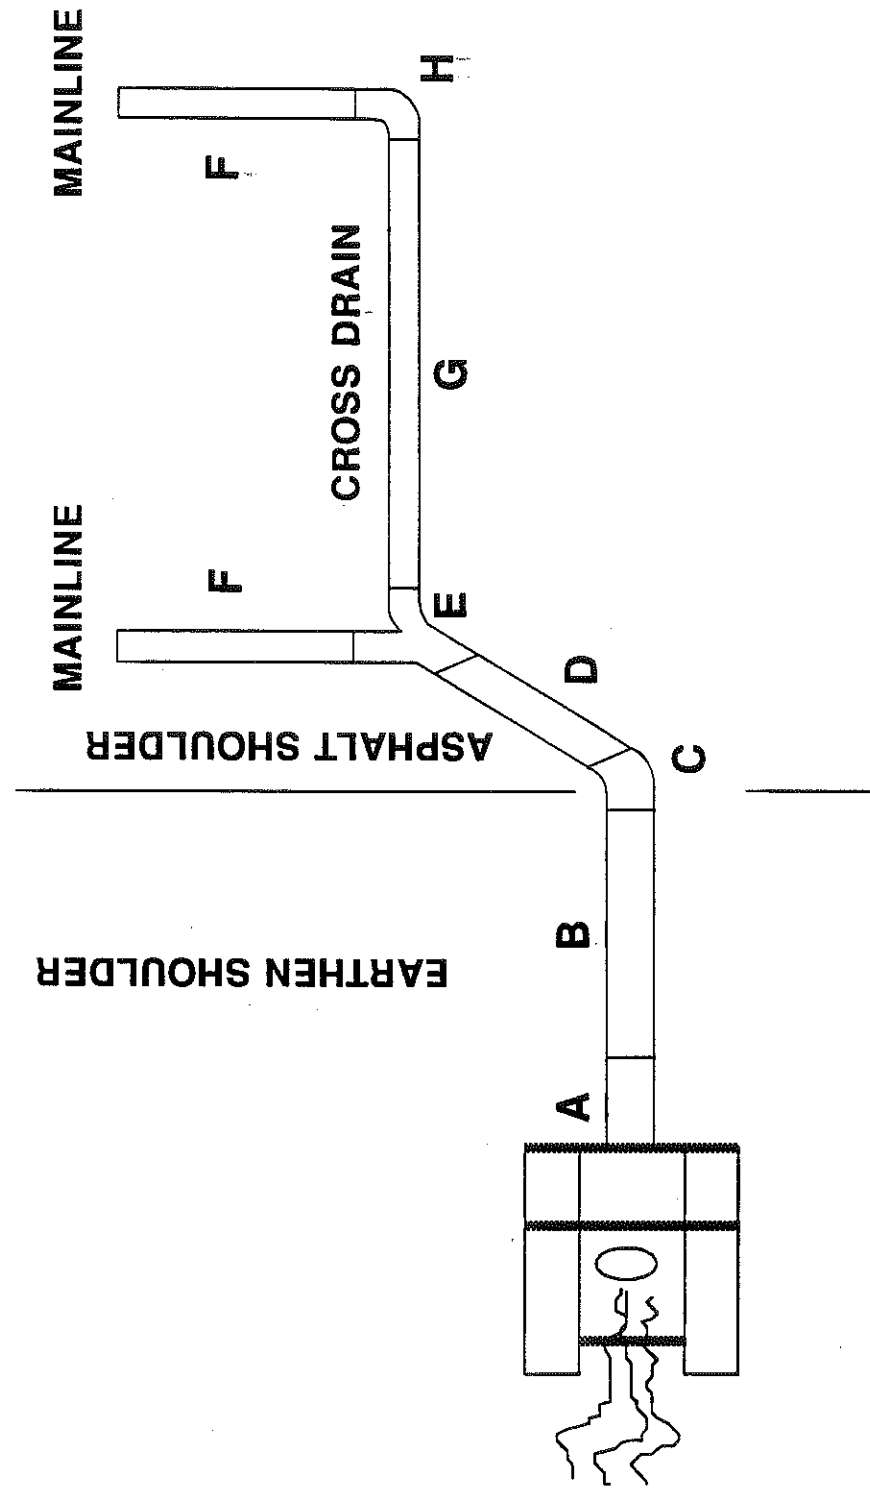
DRAWING NO. 1

The pipes were inspected for sags, siltation, standing water, compression, rips, and other noticeable distress. The assigned outlet pipe sections are shown in Drawing's 1 through 3. Approximately 18 percent of the outlet pipes that were inspected were less than 50 percent open. On the Western Kentucky Parkway, "T" connectors were modified to four-way connectors by cutting and splicing an additional pipe into the top of the "T". In several cases, the additional pipe was pushed too far into the coupling thereby blocking the outlet end of the "T".
